SUBJECT: Eastland Lake Dam
Bates County, Missouri
Missouri inventory No. 20444

EASTLAND LAKE DAM
BATES COUNTY, MISSOURI
MISSOURI INVENTORY NO. 20444

PHASE I INSPECTION REPORT
NATIONAL DAM SAFETY PROGRAM

AUGUST, 1980

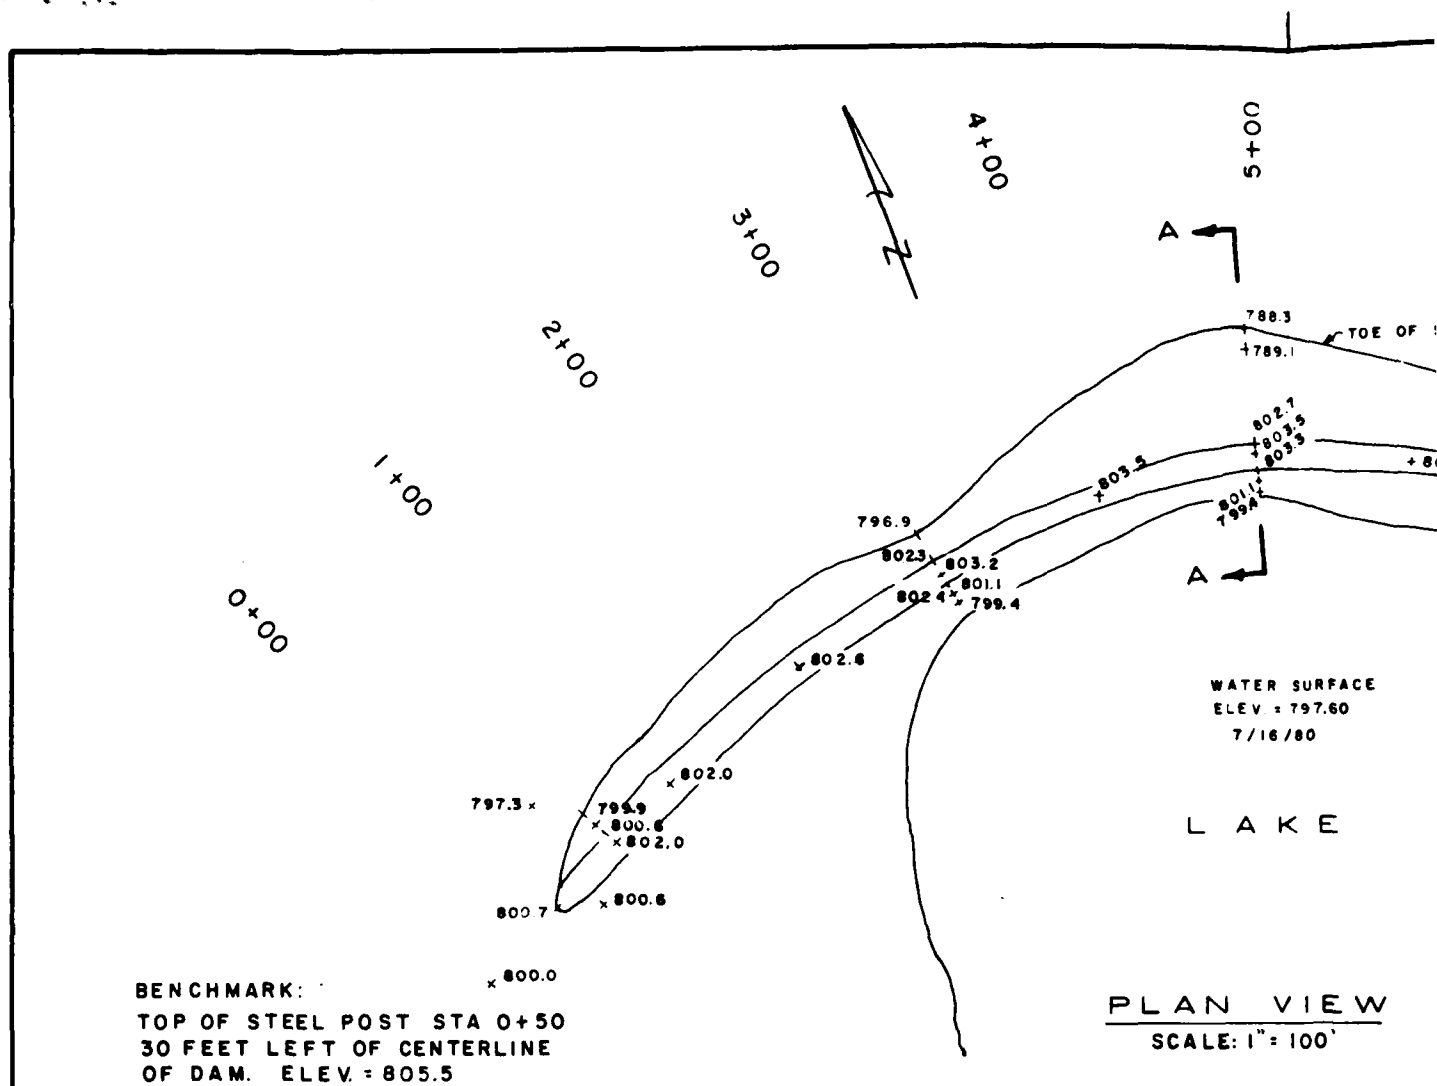
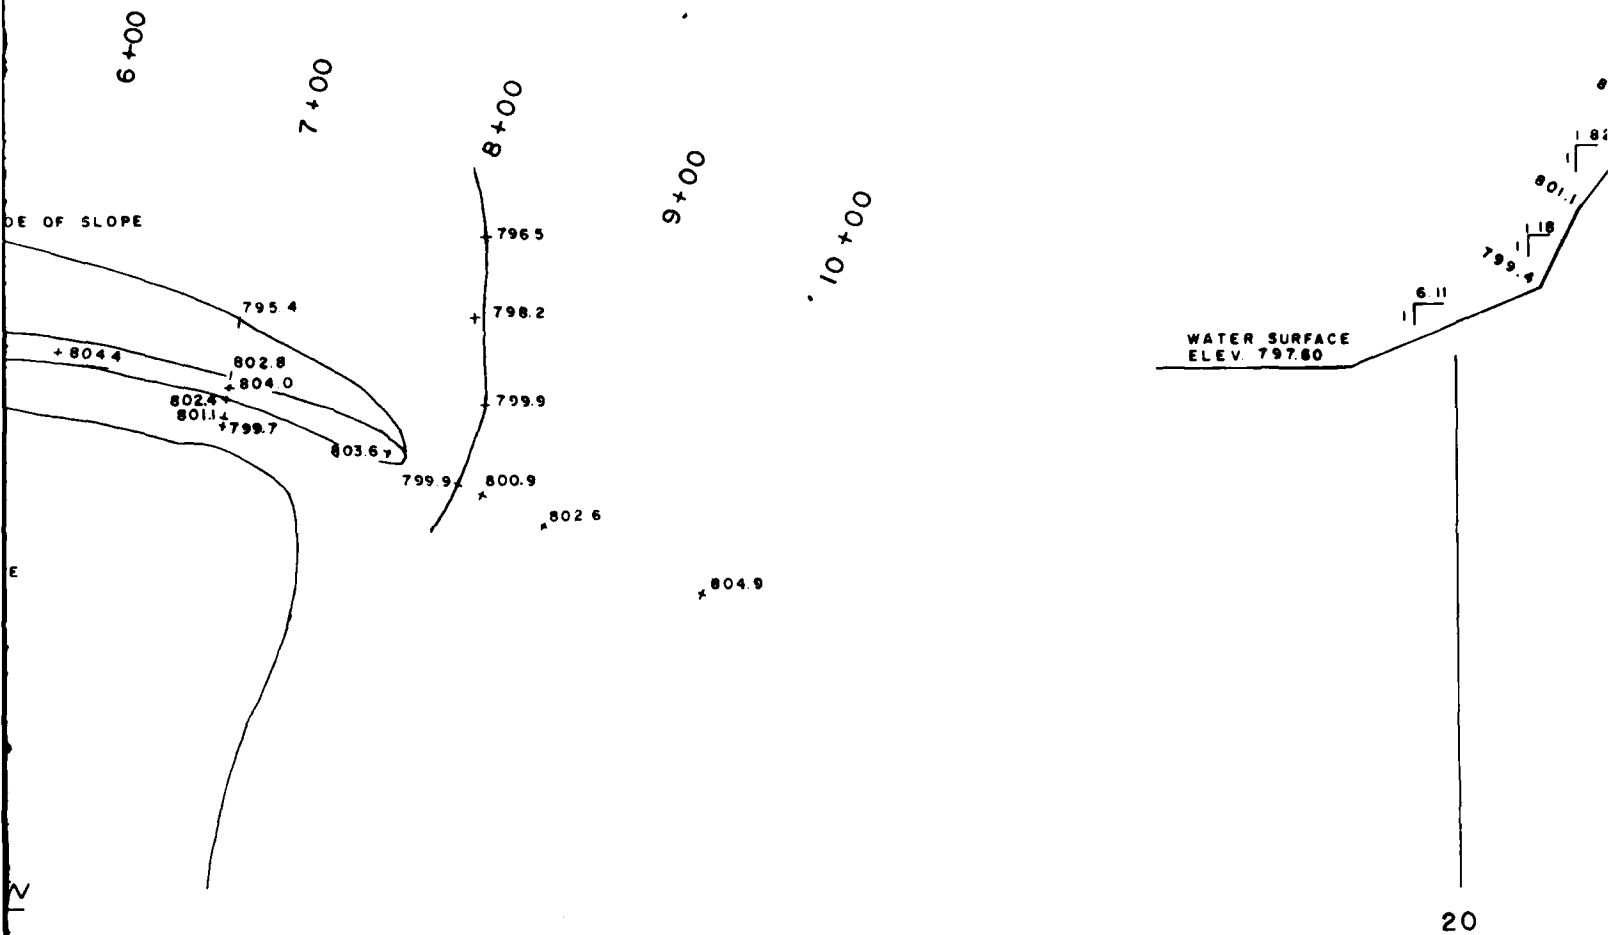
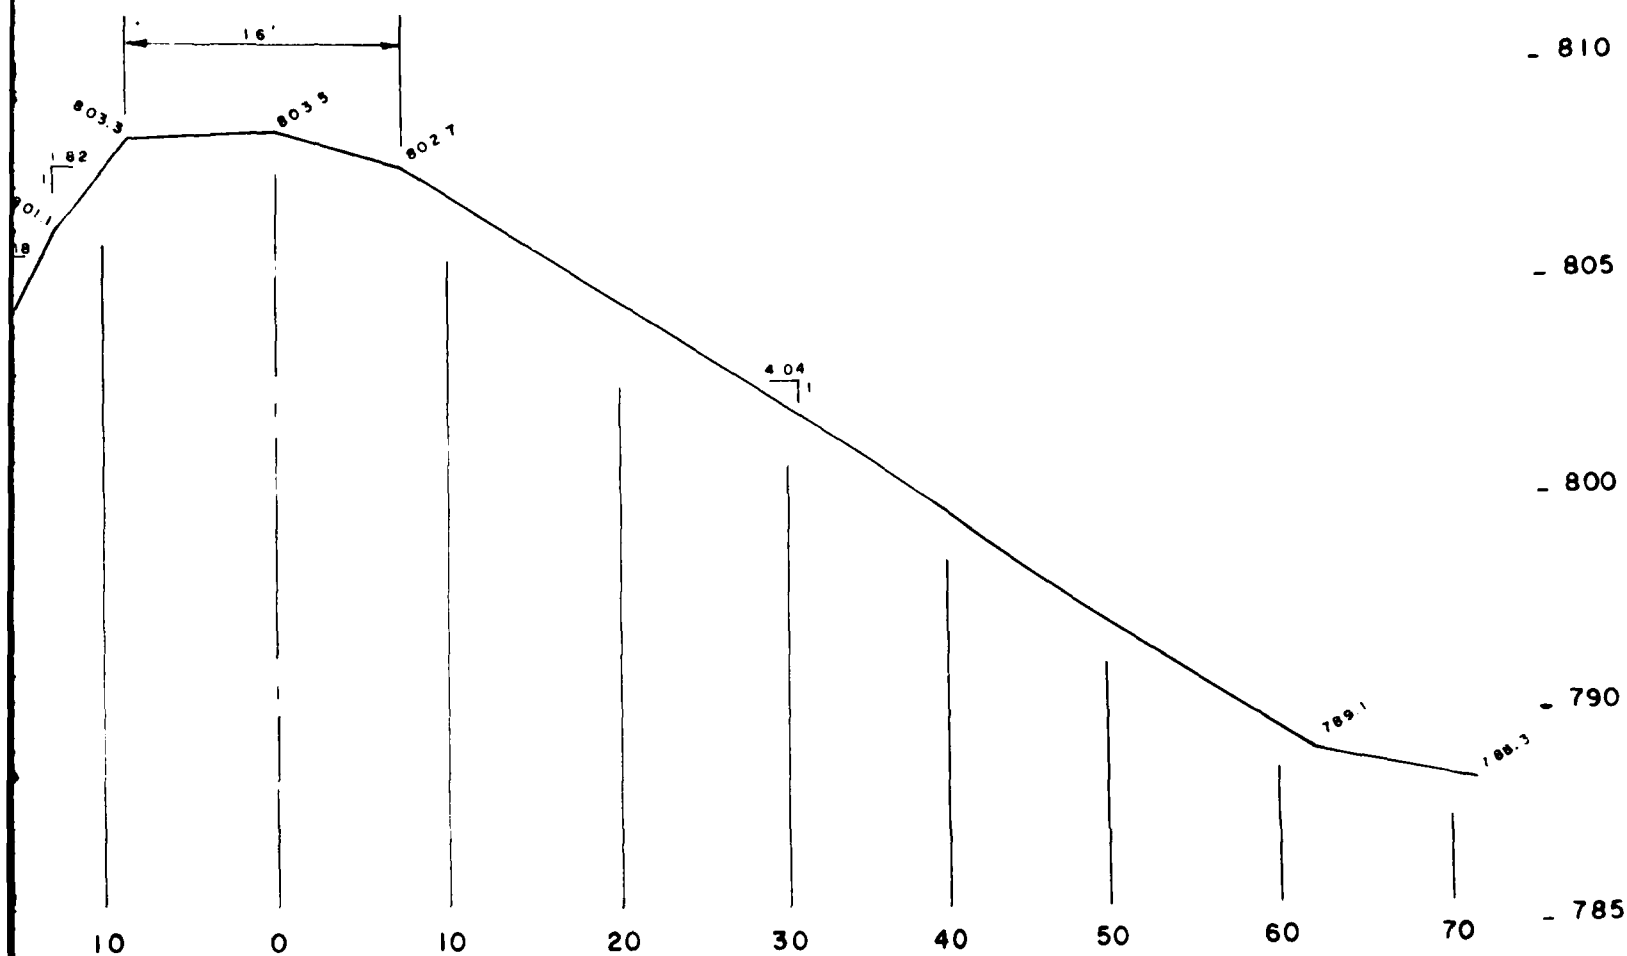
SHEET 3 APPENDIX A

Sheet 3 of Appendix A shows a plan, profile, and typical section of the embankments. Sheet 3A of Appendix A shows a profile and section of the spillway.
